Access Study to all Pertinent Parts of  
Dam Projects During High Reservoir  
Conditions

# Upper Connecticut Basin New Hampshire and Vermont

JULY 1992

US Army Corps  
of Engineers  
New England Division

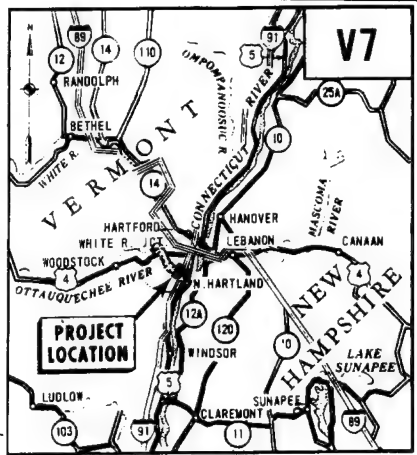
2. Existing Access. The downstream toe area is an approximately 200 foot wide flat grassy area with some low lying brush. The downstream toe is flanked by steep abutments which can only be reached by light weight equipment. The downstream toe area of North Hartland Dam can be reached by using Access Road "C". Access Road "C" is a gravel road which extends westerly from Vermont state Route 5 to the dam. It can be used up until spillway discharge conditions occur. Heavy equipment used Access Road "C" during the past few years to construct the hydro unit at the dam.

3. Adequacy of Access. Access to the downstream toe of North Hartland Dam is inadequate. Heavy equipment may bog down in the grassy downstream toe area and cannot traverse the steep adjacent abutment slopes. Spillway discharges would prevent access to the area by blocking Access Road "C". Providing access to the downstream toe during spillway discharge is beyond the scope of this study.

4. Recommended Improvements. Access Road "D" should be constructed to allow heavy equipment to reach the downstream toe of North Hartland Dam without bogging down. Access Road "D" construction would require removal of existing vegetation and soft material along the proposed road alignment and then placement of 12 inches of gravel. Vegetation should be periodically removed from the dam abutment interfaces to allow for inspection of the interfaces and light weight equipment to traverse the interfaces.

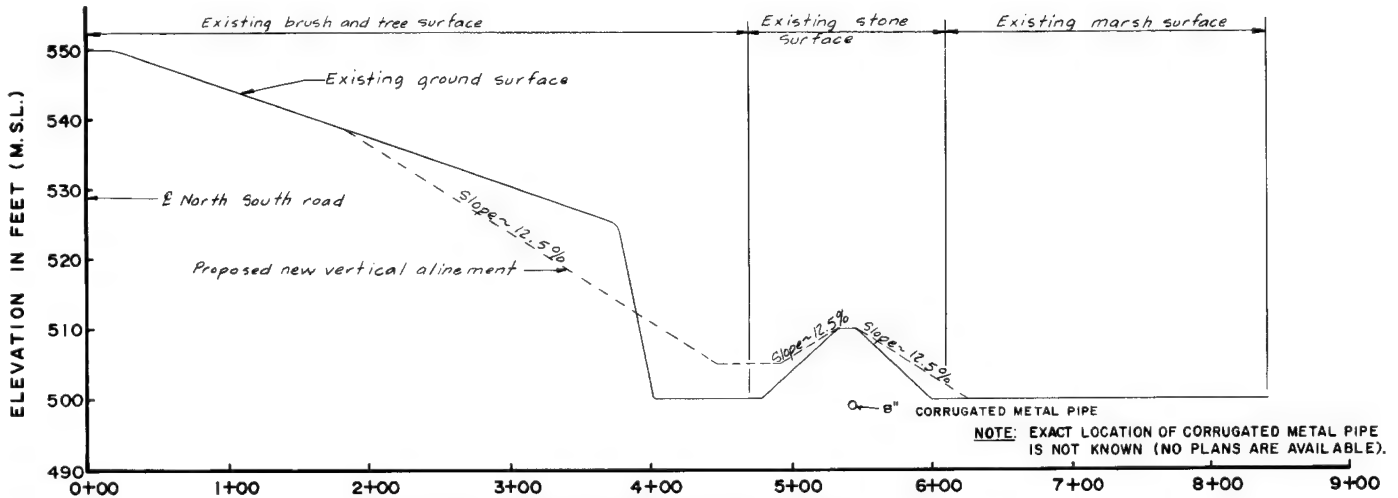
**PROPOSED ACCESS ROAD "N" PROFILE**

NOTE: EXACT LOCATION OF CORRUGATED METAL PIPE IS NOT KNOWN (NO PLANS ARE AVAILABLE).
